Analysis of the Impacts of Irregular Development of Hillside Areas and Water Erosion in Brazzaville, Republic of Congo: The Case of Quartier Don Bosco in Arrondissement 9 Djiri

Innocent Joachim EMVOULOU^{1*}, Benoît Tameon DANVIDE², Jean de Dieu NZILA³, Reisch Vanel ATTIPO⁴, Tak Youssif GNONGBO⁵

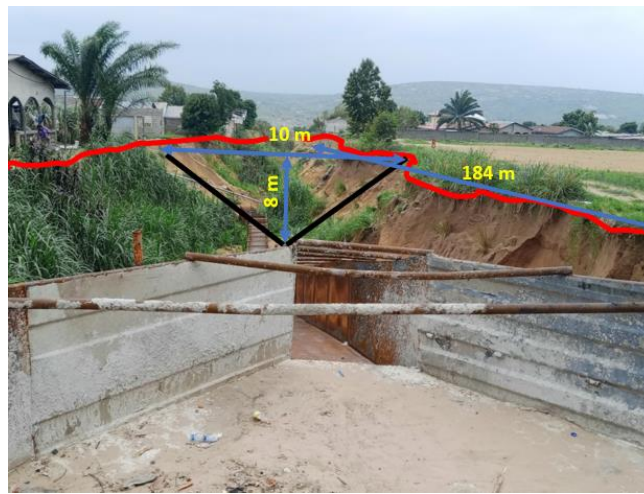
Photo 1: Measurements of gully section 1 (2023-2024)

This photo illustrates the exercise of taking different measurements of the ravine, for example in section n°1, corresponding to the period 2023-2024. This is how we obtained the quantification data for this gully.

The data obtained from the three-dimensional measurements of the ravine have enabled us to identify three periods of its evolution: 2012-2022, 2022-2023, and 2023-2024 (Table 1). The main measurements are the width and depth of the section and length of the gully for each period analyzed (Photo 1).

N°	Periods	Width (m)	Depth (m)	Section (m^2)
1	2023-2024	10	8	40
2	2022-2023	20	15	150
3	2012-2022	45	20	450

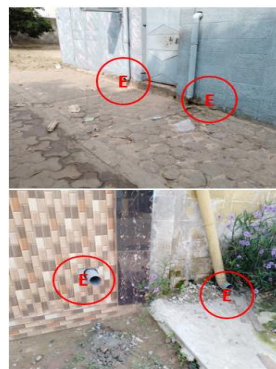
Plate 1: Gutters draining rainwater into the street

E- Rainwater drainage pipes.

The photos above show rainwater drainage pipes oriented towards the street.

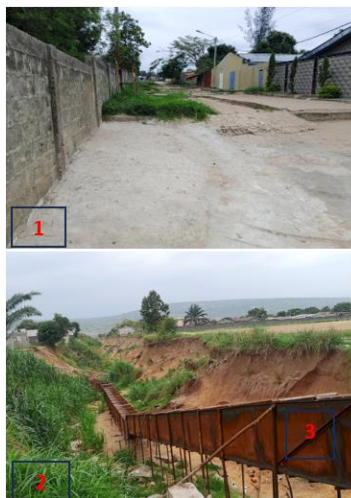
Plate 2: Landscaped street ending in the Don Bosco ravine (Itatolo neighborhood, Djiri)

Legend: 1- Avenue of the Don Bosco Institute (1,100 m), leading to the ravine; 2- Ravine de Don Bosco; 3- Water channeling structure.

The main avenue of the Don Bosco housing estate is in its undestroyed part, 1,100 metres long, starting from national road no. 2 (RN2), where erosion by gullyng is triggered by the concentration of runoff water. It is paved with cement cobblestones for 750 metres and is built on a 13.5% slope leading directly into the ravine (Photo no. 2).

The Don Bosco ravine develops along this avenue in a regressive dynamic, starting from the talweg of one of the branches of the Itatolo river, towards the main road n°2. It is one of Brazzaville's active ravines. In its upper reaches, it progressed over a length of 234 m, with a width of 10 m and an average depth of 8 m between 2022 and 2024. As it progressed, it swept away the 194 m-long boundary walls of the Don Bosco complex. All in all, the gully developed, as outlined above, over a length of 660 m between 2012 and 2024, washing away 14,910 m² of built-up area, i.e. 37 plots.
